LITTLE YOUGHIOGHENY RIVER SITE NO. 5

NDI ID NO. MD 55

PHASE I INSPECTION REPORT

NATIONAL DAM INSPECTION PROGRAM

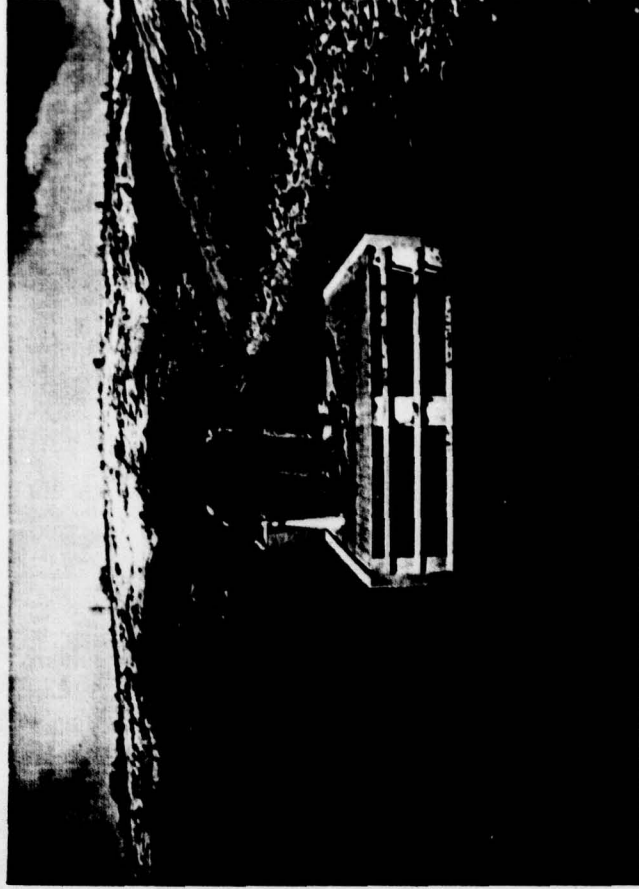
PHOTOGRAPH 4 View of principal spillway riser.
